SALMONID HABITAT LIMITING FACTORS WATER RESOURCE INVENTORY AREA 32 WALLA WALLA WATERSHED

FINAL REPORT
4/1/2001

Mike Kuttel, Jr.
Washington State Conservation Commission
300 Desmond Drive
Lacey, Washington 98503

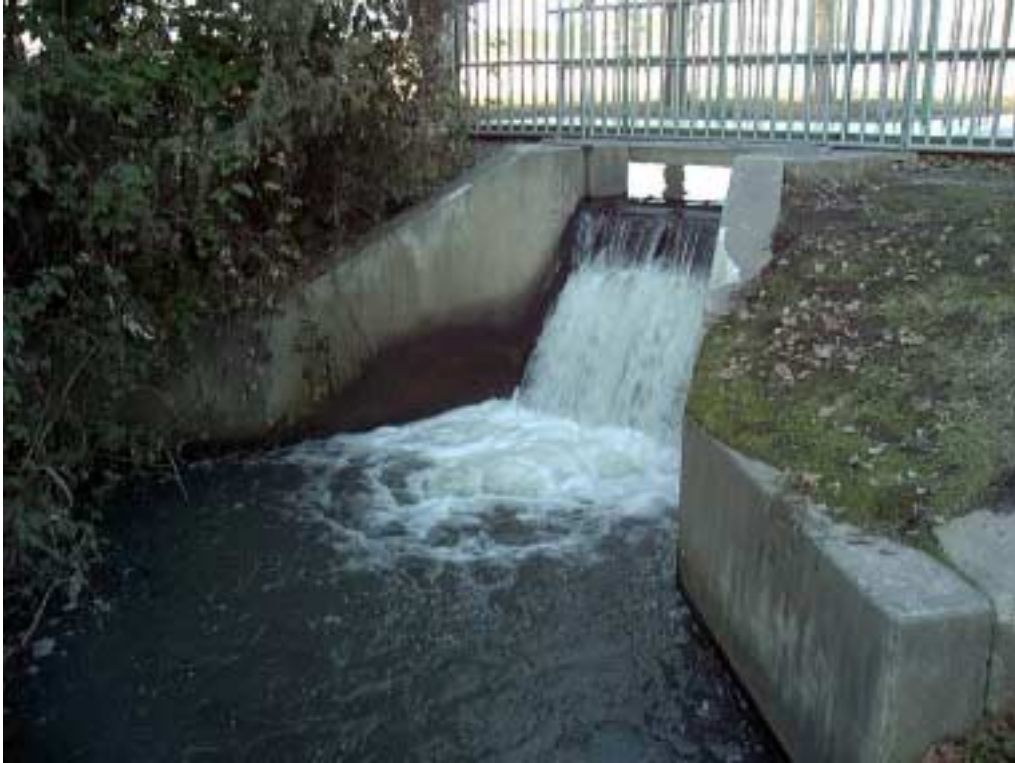
Figure 23. Lion's Park Pond Dam on Garrison Creek. Photo taken February 2001.

U.S. Army Corps of Engineers (USACE) (1997) identified four channel spanning barriers on Yellowhawk Creek and two channel spanning barriers on Garrison Creek. At least three barriers are present on Garrison Creek in addition to the barriers identified by the USACE. A concrete dam at the outlet of Lion’s Park pond in College Place is a substantial barrier. A culvert that runs under Larch Street and an ornamental pond immediately downstream from Larch Street are also barriers (Kuttel 2001). See [Figure 23](#) below. Garrison Creek is highly urbanized with numerous ornamental water gardens and water wheels in place on the creek. Yellowhawk Creek is less urbanized than Garrison Creek (TAG 2000 Personal Communication). Falbo Ditch is located on Yellowhawk Creek 0.3 miles upstream from Walla Walla High School. Water spills over a 4’ high diversion dam onto a concrete apron. Williams Ditch is located on the left bank of Yellowhawk Creek about 700’ downstream from the Union Pacific railroad crossing. The concrete diversion dam spans the entire channel. Water spills on a concrete apron perched 2.5’ above the stream channel (Montgomery Watson 1999). Walla Walla Conservation District (WWCD) has scheduled instream work to correct the passage problems at Falbo and Williams Ditches for the summer of 2001 (Smith, L. 2000 Personal Communication). The City of College Place has eliminated one of the two barriers listed above on Garrison Creek (Neve, W. 2000 Personal Communication).

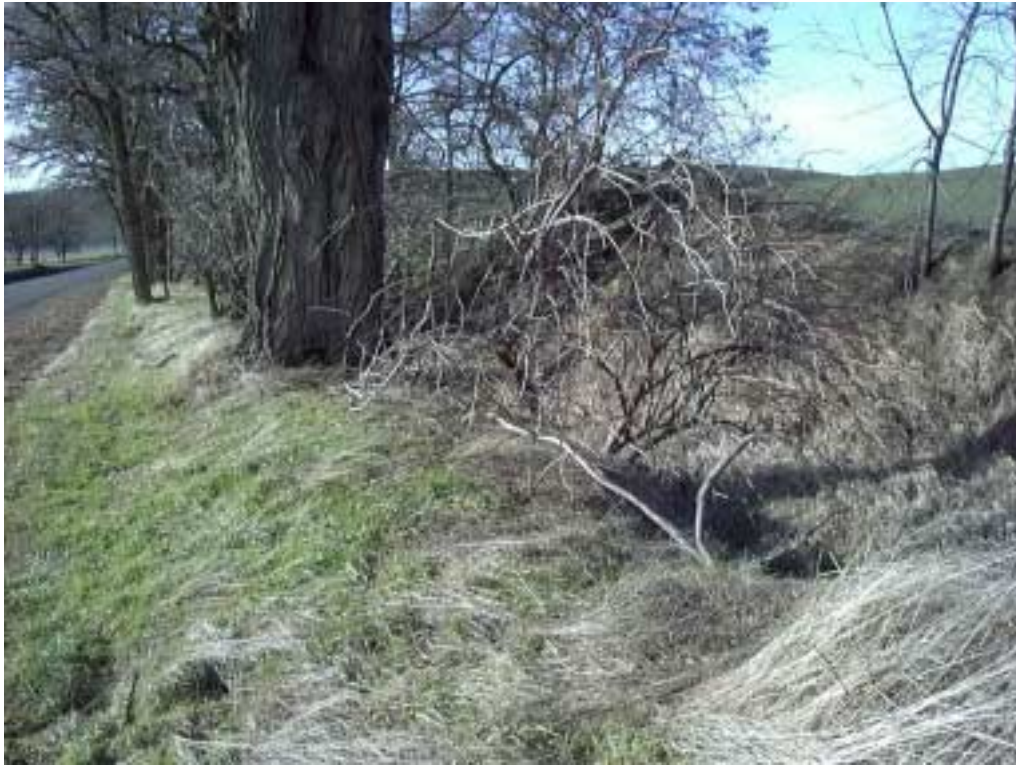
Figure 24. Riparian zone on Russell Creek next to Scenic Loop Road. Photo taken January 2001.

All three of these streams flow through vast areas of dryland agriculture. In many cases the land has been farmed to the edge of the streambank, leaving no riparian buffer on the floodplain. Where woody vegetation is present it is usually found in a thin strip, often growing up out of an incised stream channel (Tice, B. 2001 Personal Communication, Kuttel 2001). Cottonwood Creek originates in wooded ravines in the Oregon portion of the Blue Mountains. The Washington portion of the stream has a narrow strip of riparian vegetation along much of its length (Mendel, G. 2001 Personal Communication). See [Figure 24](#) below.

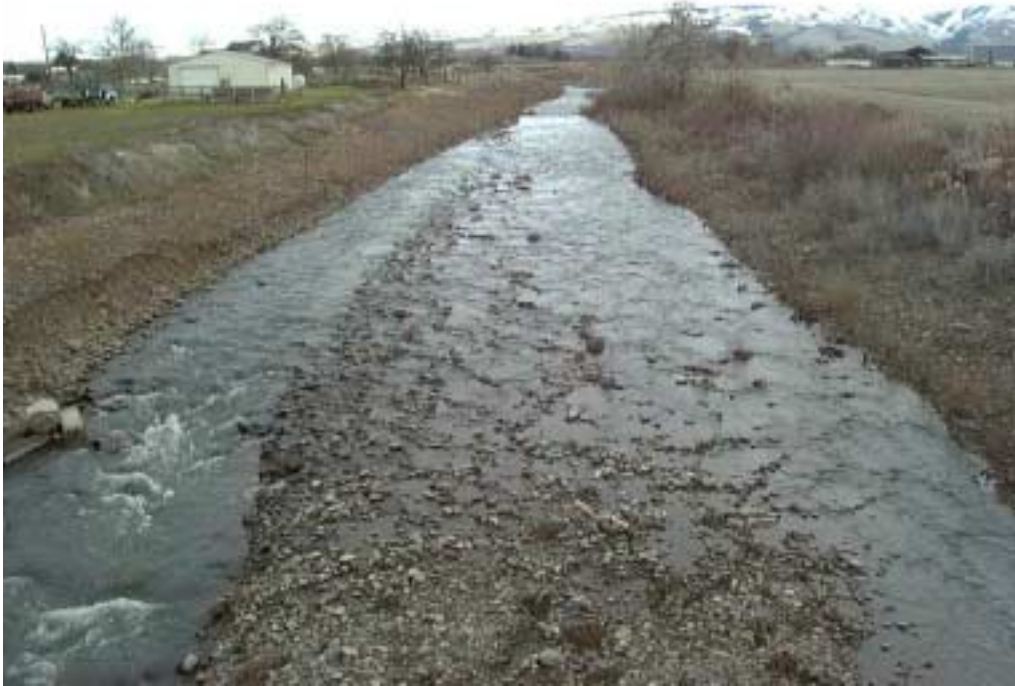
Figure 25. Cottonwood Creek above Powerline Road. Photo taken January 2001.

Cottonwood Creek near Powerline Road is very wide and shallow. No riparian buffer is present along this reach. The channel has also been straightened. It appears that this stream is subject to high flow events in the winter that combined with the straight channel and lack of riparian vegetation led to creation of an excessively wide channel. Many reaches on Russell and Reser Creeks are deeply incised (Tice, B. 2001 Personal Communication, Kuttel 2001). See [Figure 25](#) below.
